**2007 Operations, Maintenance,
and Monitoring Report**

**Vermilion River Cutoff Bank
Protection**

State Project Number TV-03
Priority Project List 1

August 2007
Vermilion Parish

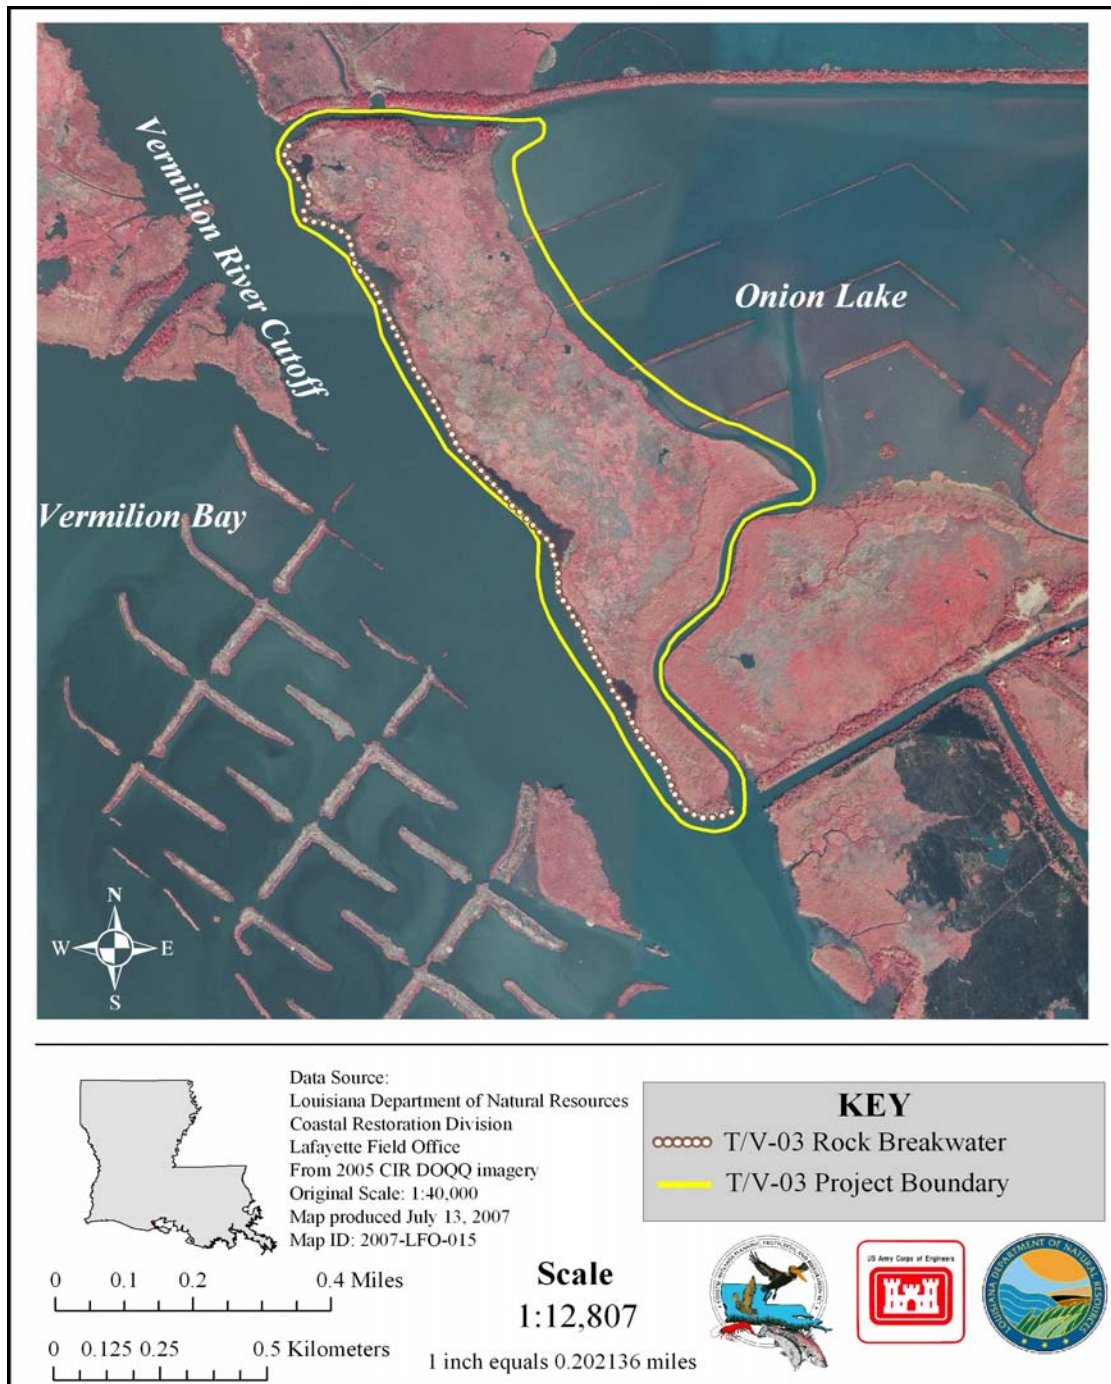
The project was originally designed to stabilize the west side of the cutoff by armoring the three remaining land points adjacent to Vermilion Bay with limestone rip-rap. It was also designed to protect the east side of the cutoff from further erosion through the use of 8,900 ft (2,713 m) freestanding rock breakwater. The original plan was redesigned due to cost overruns. The continuous dike along the west bank and sediment trapping features were eliminated. The constructed project consists of 6,269 ft (1,911 m) of foreshore rock dike along the east bank of Vermilion River Cutoff. The original boundary for the project area in 1993 (USACOE 1993) did not include the entire area where the shoreline structure was constructed. The revised boundary for the project area was adjusted to encompass the rock dike to better evaluate the project area over time. Construction of the breakwater was complete in February 1996 (figure 1).

Figure 1. Vermilion River Cutoff Bank Protection (TV-03) project area map showing location of rock breakwater.

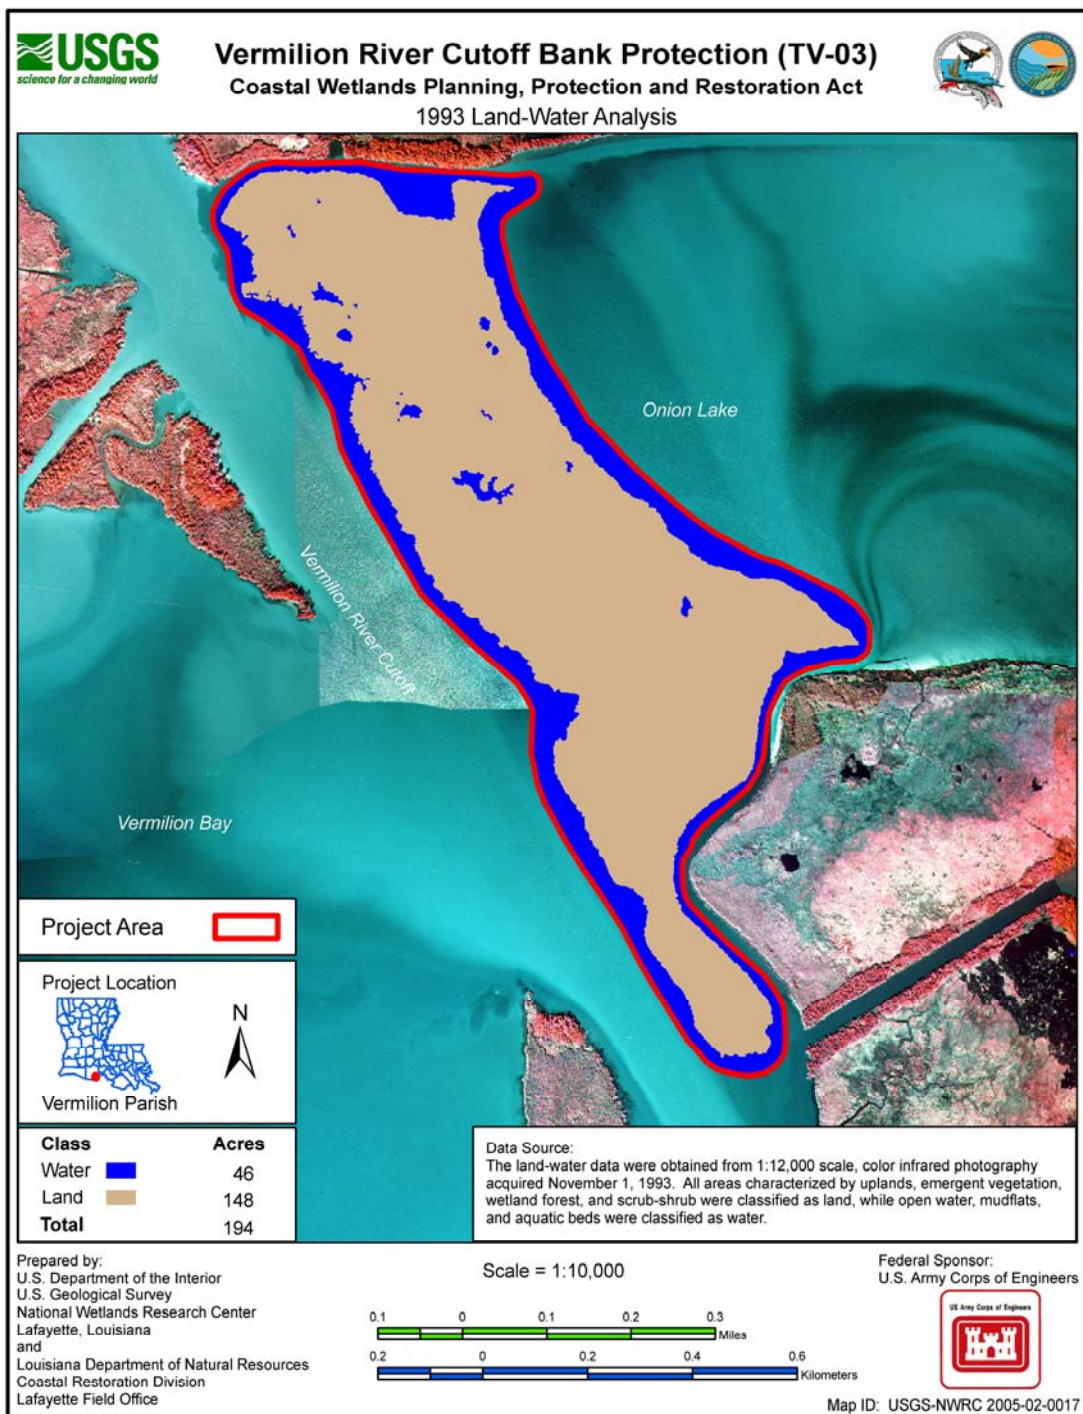
The original boundary for the project area in 1993 did not include the entire area where the shoreline structure was constructed. The revised boundary for the project area was adjusted to encompass the rock dike to better evaluate the project area over time. Comparison of the 1993 land to water analysis to the analysis for 2002 shows an increase in land by 1 ac (figures 2 and 3). This is likely attributed to inclusion of the dike footprint and partial terraces in the “land” delineation. The significant finding is no net loss in the project boundary.

Figure 2. Pre-construction Land to Water analysis for Vermilion River Cutoff Bank Protection (TV-03) project area for 1993.

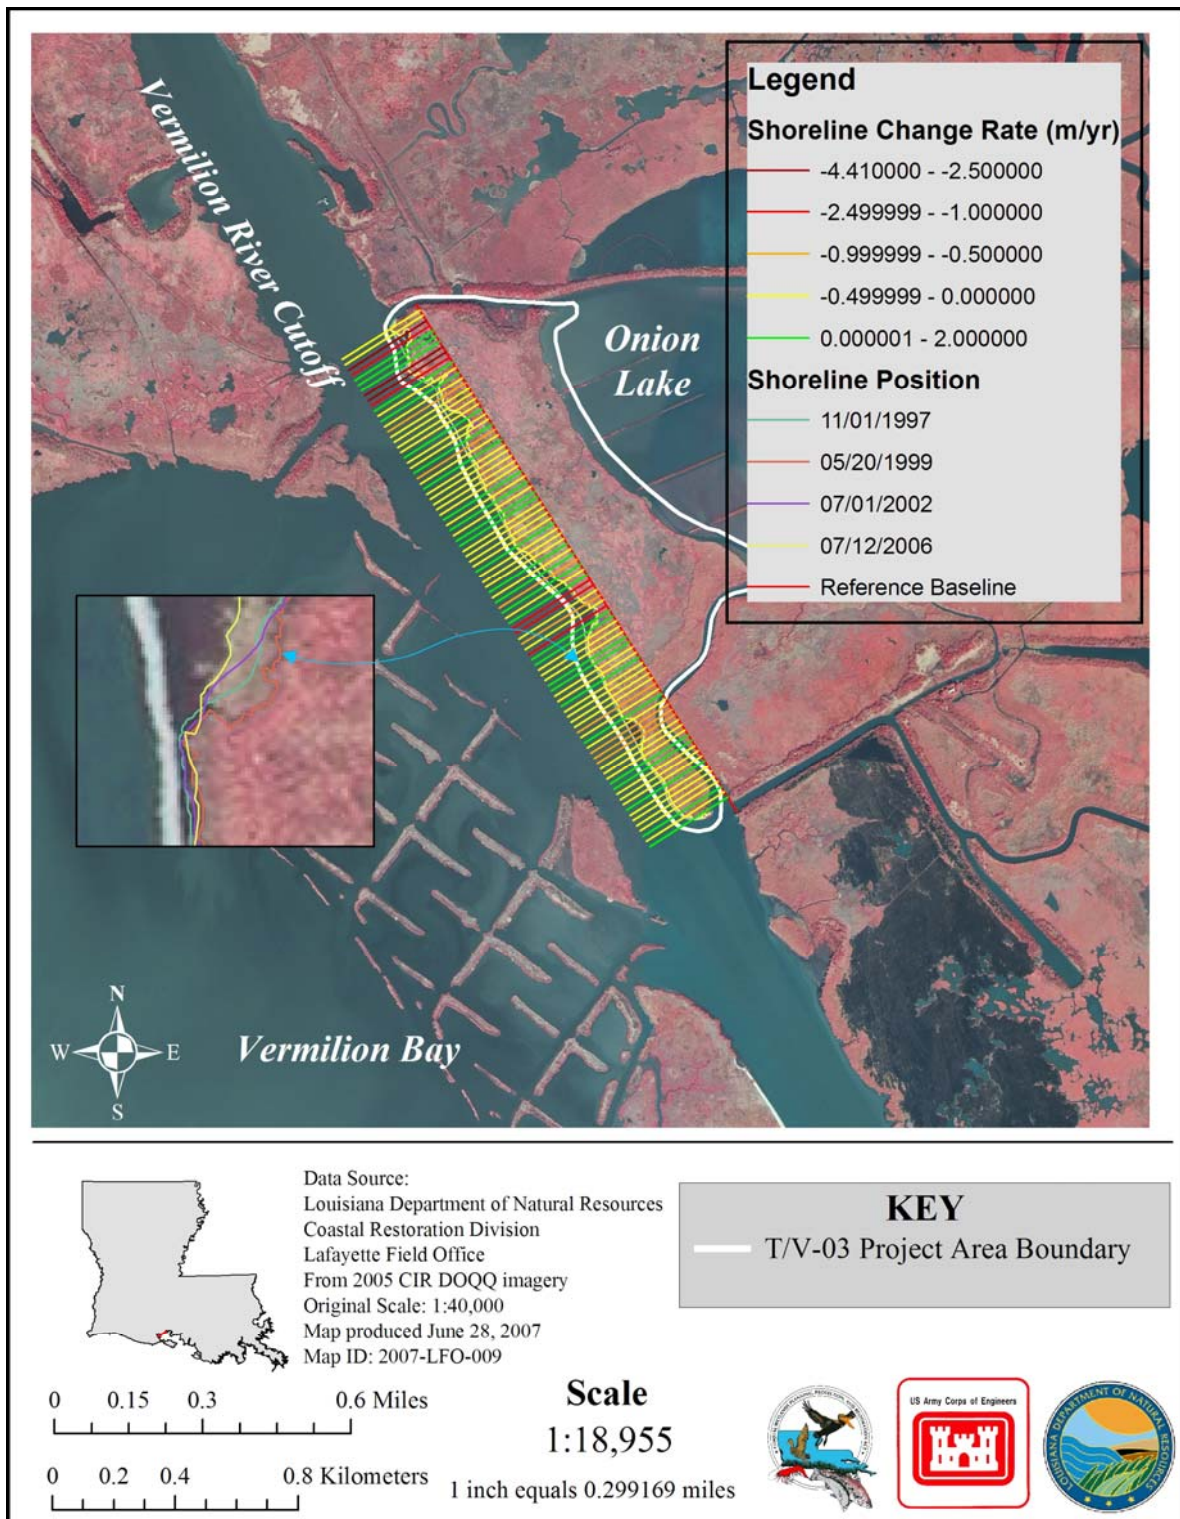
Land to water analysis for 2002 indicates 45 acres of open water and 149 acres of land in the project area (figure 3). Aerial photography taken in 1993 was used as a baseline for shoreline position instead of the actual DGPS shoreline positions captured in 1995. This was three years prior to construction of the Vermilion River Cutoff Bank Protection (TV-03) project in February 1996, which increases the probability of error in interpreting actual land to water acreages. The data used for the shoreline analysis was from DGPS acquired by USGS and LDNR personnel. Analysis of baseline DGPS taken in 1997 was compared to DGPS taken in 1999, 2002, and 2006. The results of a shoreline analysis from 1997 and 2006 shorelines are mapped in figure 4. Change rates were calculated in m/yr for the length of the project area along transects spaced 20 m apart. Resulting change rates were determined and averaged from each transect along the shoreline. The rate of change for the project area behind the rock for the period of record November 1997 to July 2006 is an average loss of -0.24 m/yr. The results of the analysis from 2002 to 2006 DGPS are mapped in figure 5. The rate of change for the project area is an average gain of 0.27 m/yr.

Figure 4. Shoreline change map of the Vermilion River Cutoff Bank Protection (TV-03) project for the period of record of November 1, 1997, to July 12, 2006.

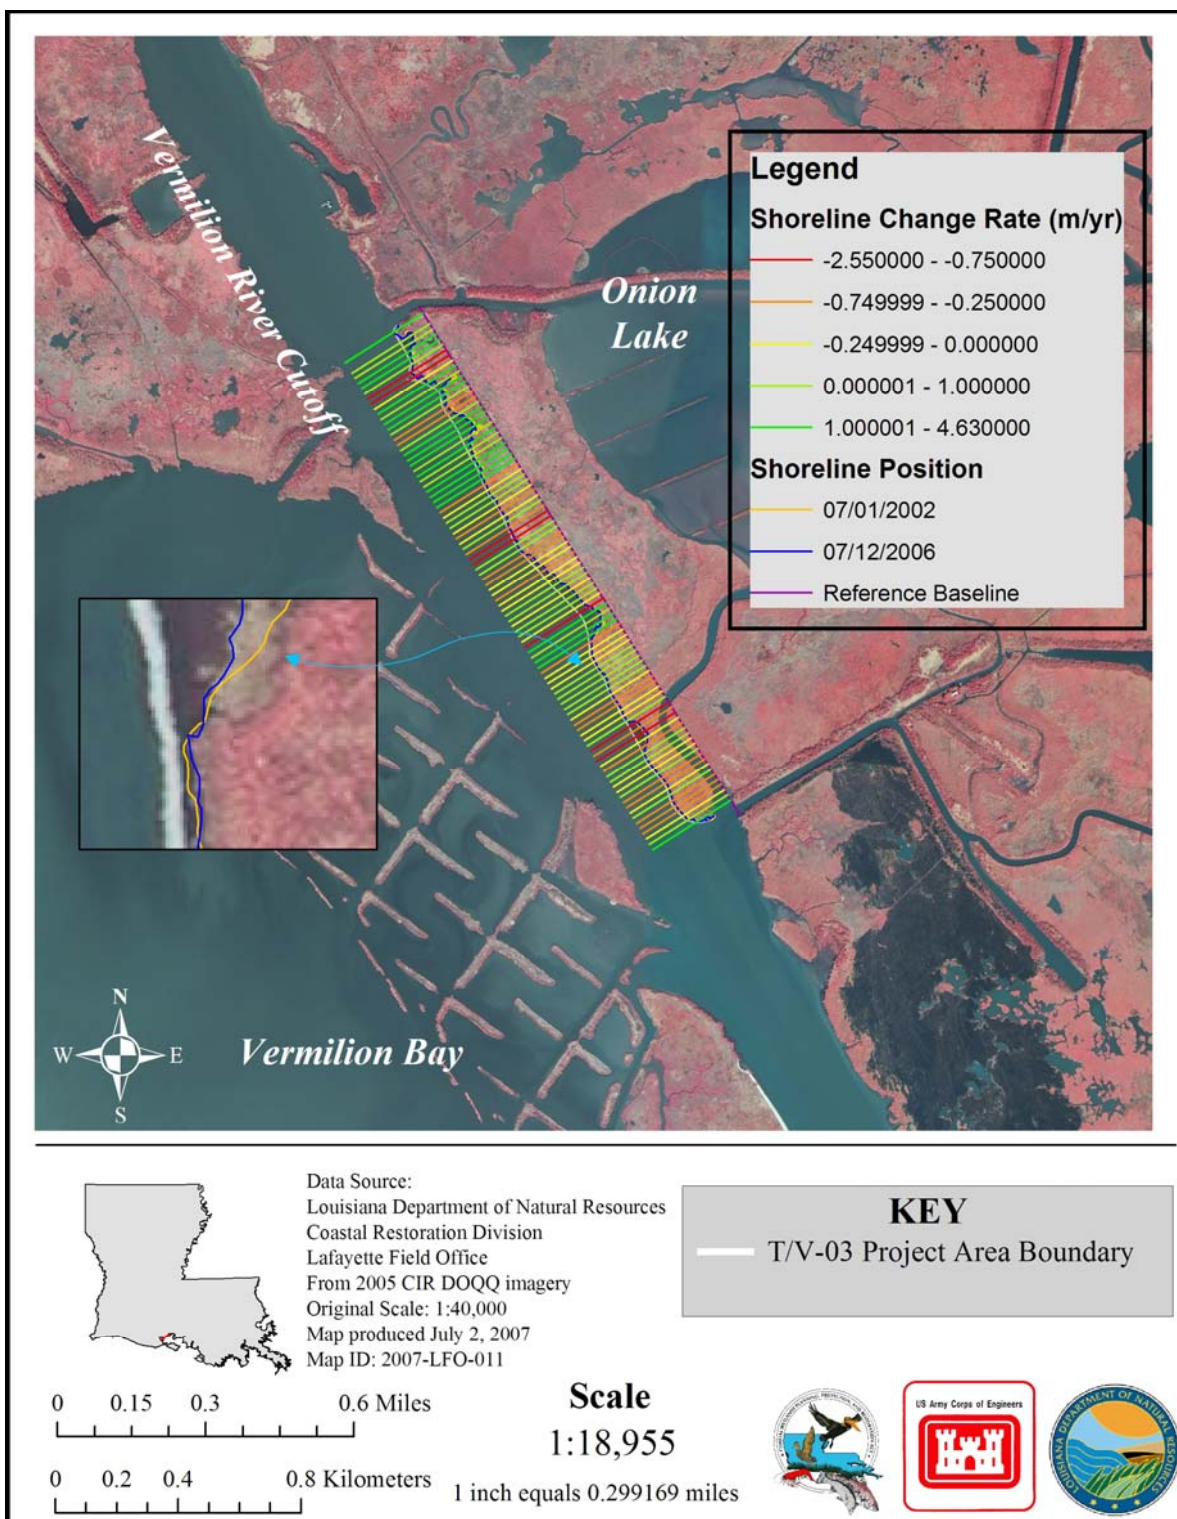
Figure 5. Shoreline change map of the Vermilion River Cutoff Bank Protection (TV-03) project for the period of record of July 9, 2002, to July 12, 2006

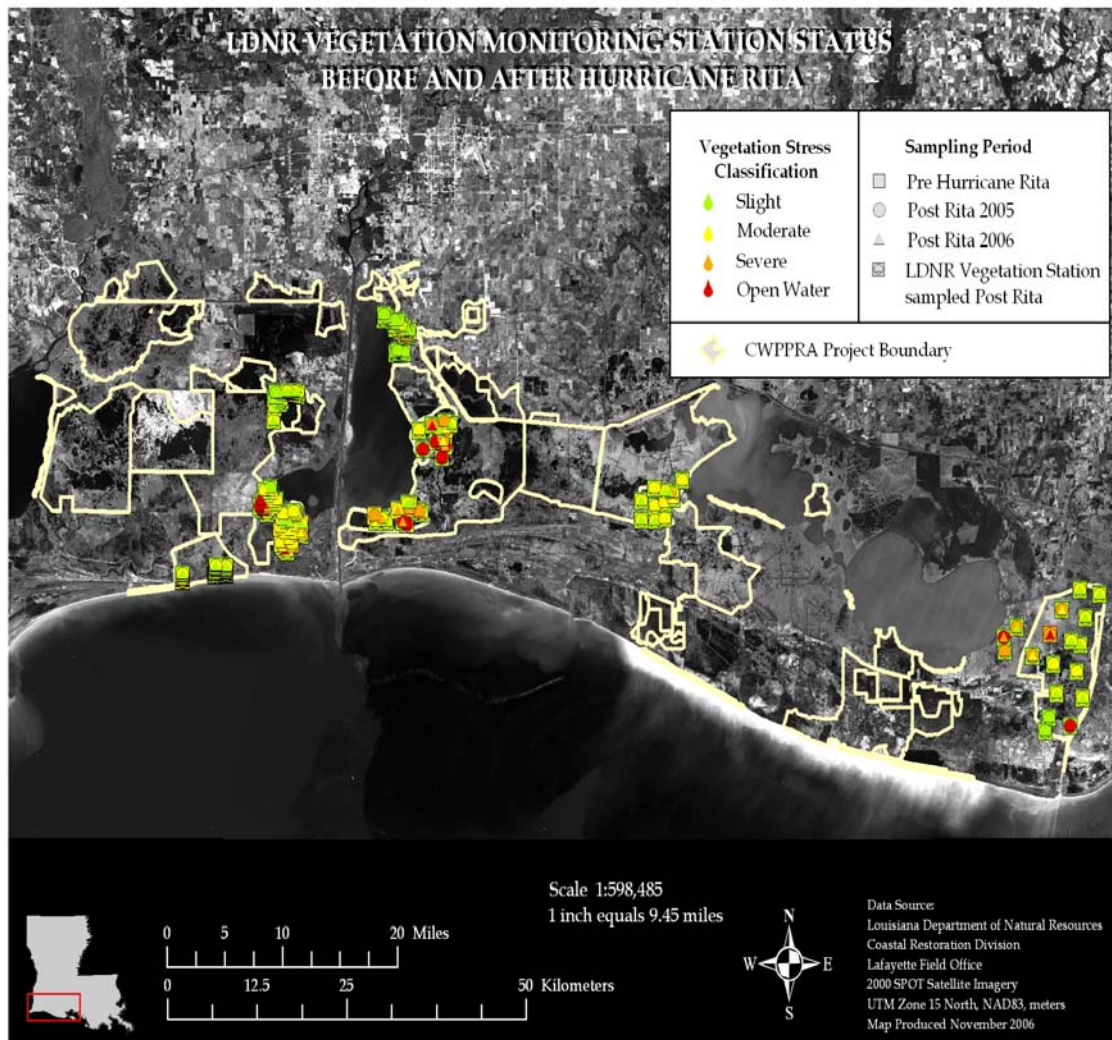
Prior to Hurricane Rita, most of the vegetation stations utilized for this survey were healthy and intact (>80%). Following the hurricane in 2005, most of the stations were stressed (67%) or worse (20%). A year later in 2006, over 50% of the stations were back to pre-storm stress levels. Severely stressed stations either converted to open water or recovered to a less stressed state. Most stations that had been converted to open water in 2005 did not recover (figures 1 and 2).

Figure 1. Location and status of LDNR vegetation stations sampled after Hurricane Rita. Stations were classified according to storm induced stress as described in Table 1.

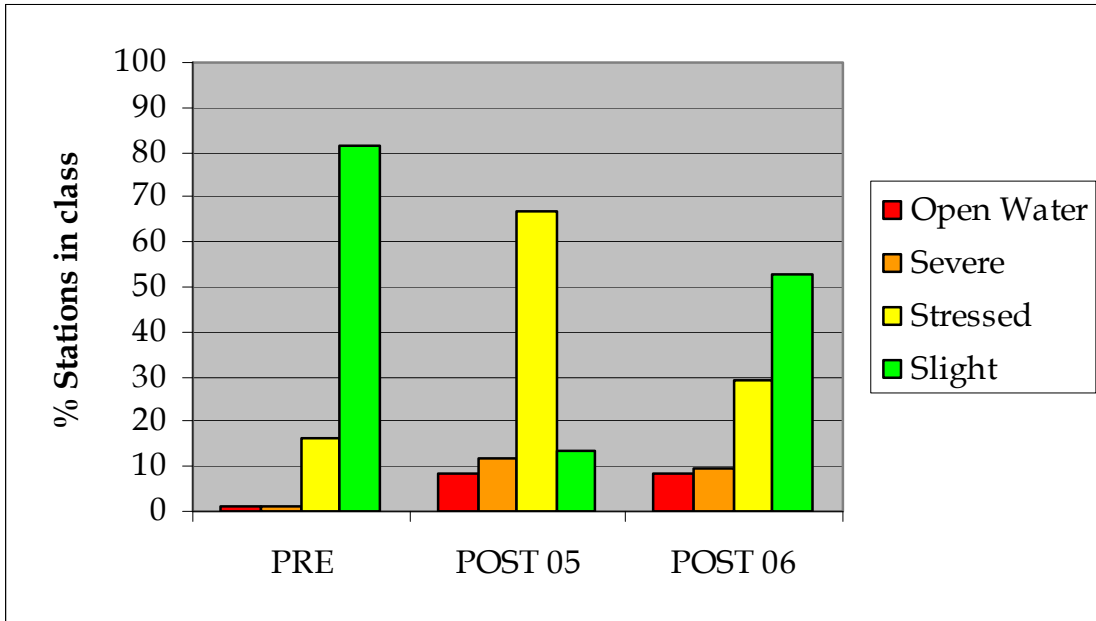
Figure 2. Percent of LDNR vegetation stations in each stress class before and after Hurricane Rita (n=163).

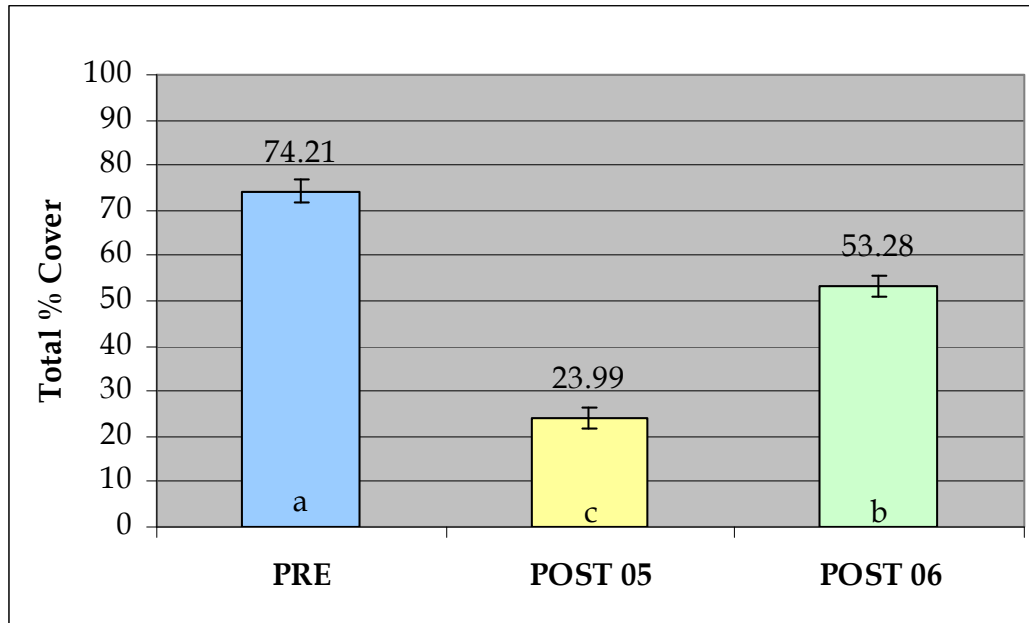
Total % Cover was significantly different over time (figure 3). Post-ANOVA comparisons (Tukey's HSD) revealed that all three sampling periods were significantly different, meaning Total % Cover for 2006 is still significantly lower than pre-Hurricane Rita levels. Species Richness was also significantly different over the three sampling periods (figure 4). The number of species present before Rita and in 2006 were statistically the same.

Figure 3. Total % Cover pre- and post-Hurricane Rita. LS Mean \pm SE, n=163 stations, $F_{2, 488}=109.7$, $p<0.0001$. Levels not connected by same letter are significantly different.

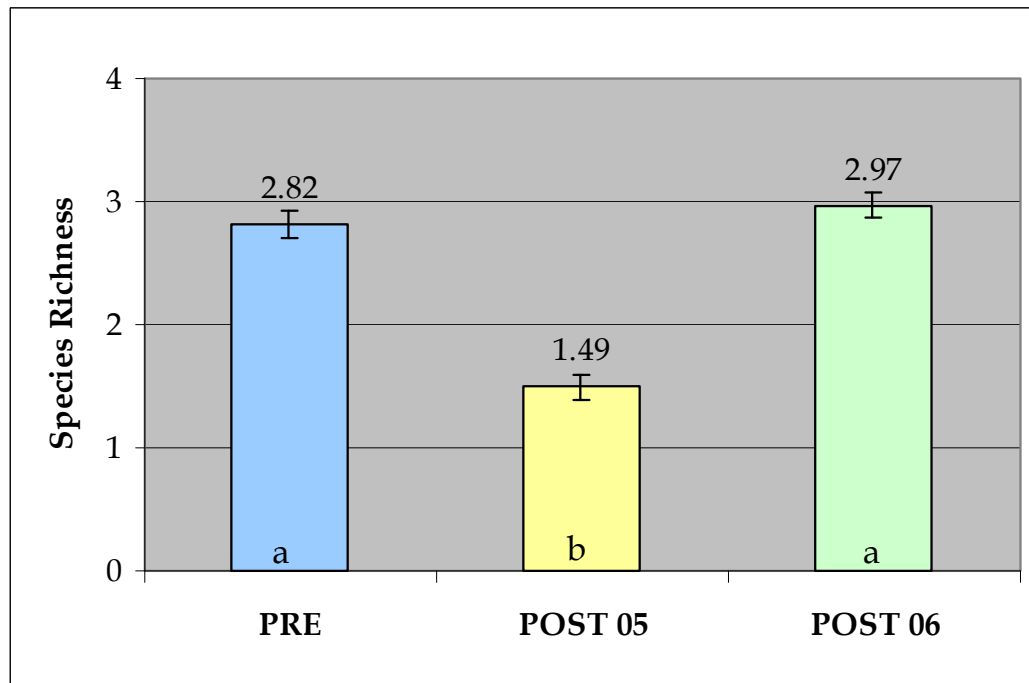
Figure 4. Species Richness pre- and post-Hurricane Rita. LS Mean \pm SE, n=163 stations, $F_{2, 488}=56.8$, $p<0.0001$. Levels not connected by same letter are significantly different.

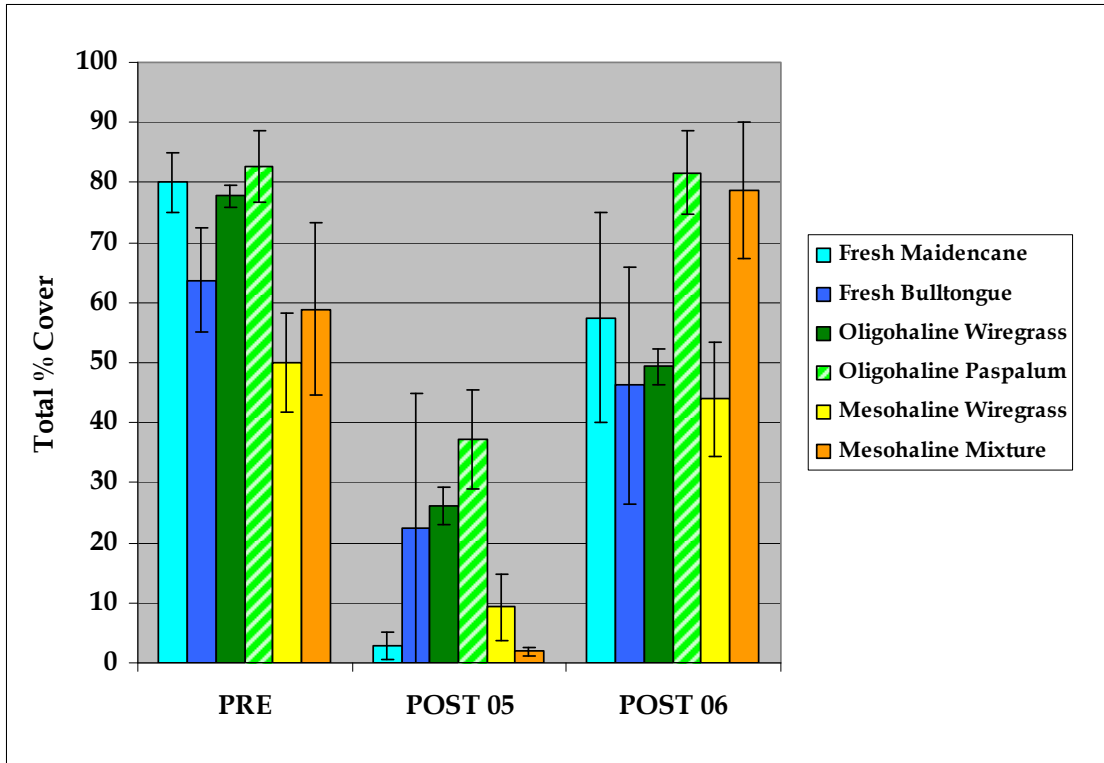
Visser Type was added to the overall model and the interaction between Visser Type and time was analyzed. Both models had significant differences in Visser Type over time (figures 5 and 6). Post-ANOVA contrasts of Cover and Richness pre-Rita and post-06 for each Visser Type revealed that all Visser Types were the same in Total Cover (had recovered to pre-storm

Figure 5. Total % Cover by Visser Vegetation Type. LS Mean \pm SE, n=163 stations, $F_{17, 488}=17.0$, $p<0.0001$.

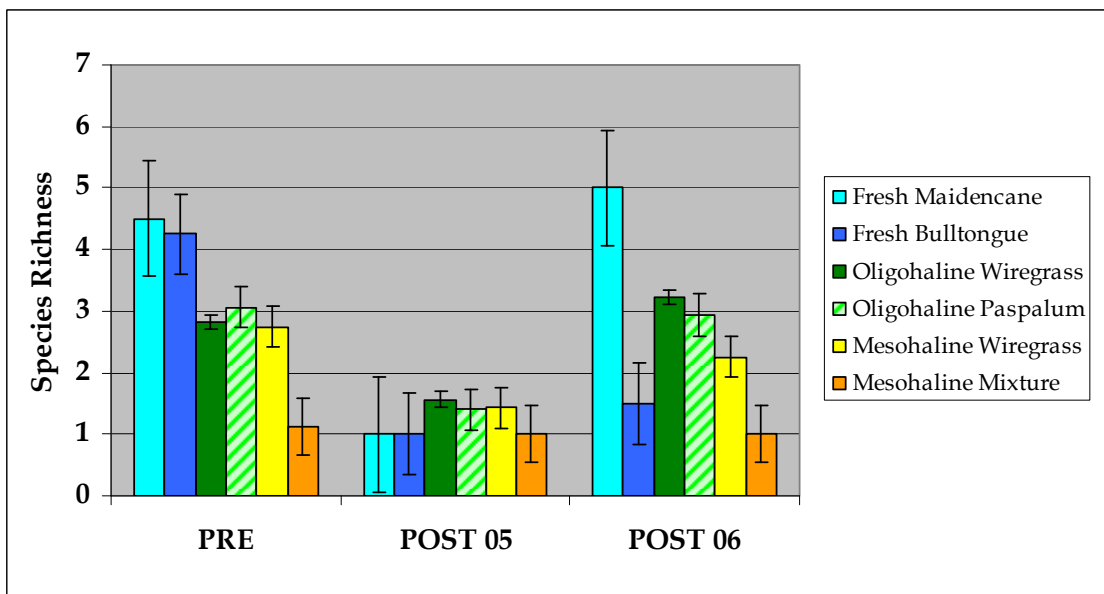
levels) and in Richness except Fresh Bulltongue (mostly in the ME-04 project area), which had not recovered, and in Oligohaline Wiregrass, which had significantly more species per plot post-Rita than before (up from 2.83 to 3.22 species).

Figure 6. Species Richness by Visser Vegetation Type. LS Mean \pm SE, n=163 stations, $F_{17, 488}=10.9$, $p<0.0001$.
